An Analysis of Possible Microbiologically Influenced Crevice Corrosion of 316 Stainless Steel in a Seawater Environment

Submitted to the Department of Ocean Engineering
on August 9, 1996 in Partial Fulfillment of the
Requirements for the Degree of Master of Science in
Oceanographic Engineering

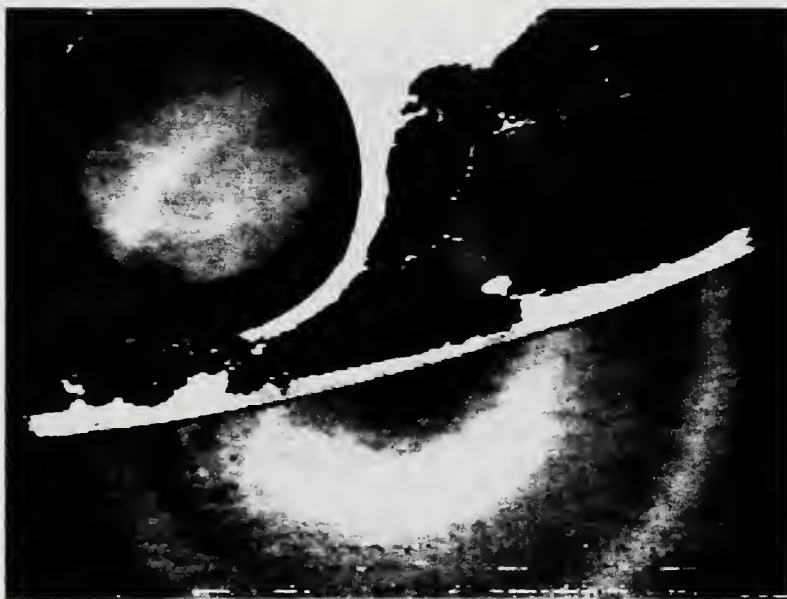
Figure 4-4 Specimen #2 Hemispherical Pits (20X magnification)

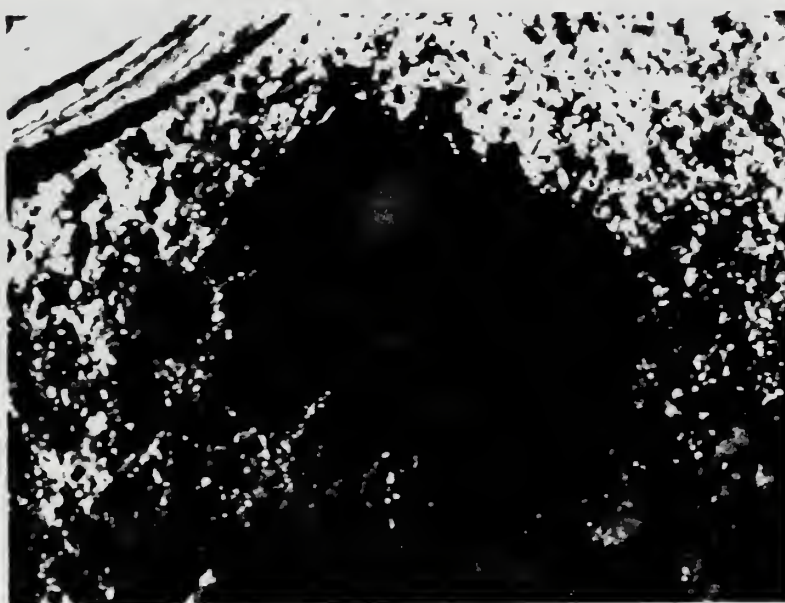
Figure 4-6 Specimen #1 Cavernous Pit (100X magnification)
